ELKHORN SLOUGH TECHNICAL REPORT SERIES 2024: 1

Current site conditions and vulnerabilities to sea-level rise and saltwater intrusion: Lower Carneros Creek, Elkhorn Slough

Emma Lasky and Olivia Won

February 2024

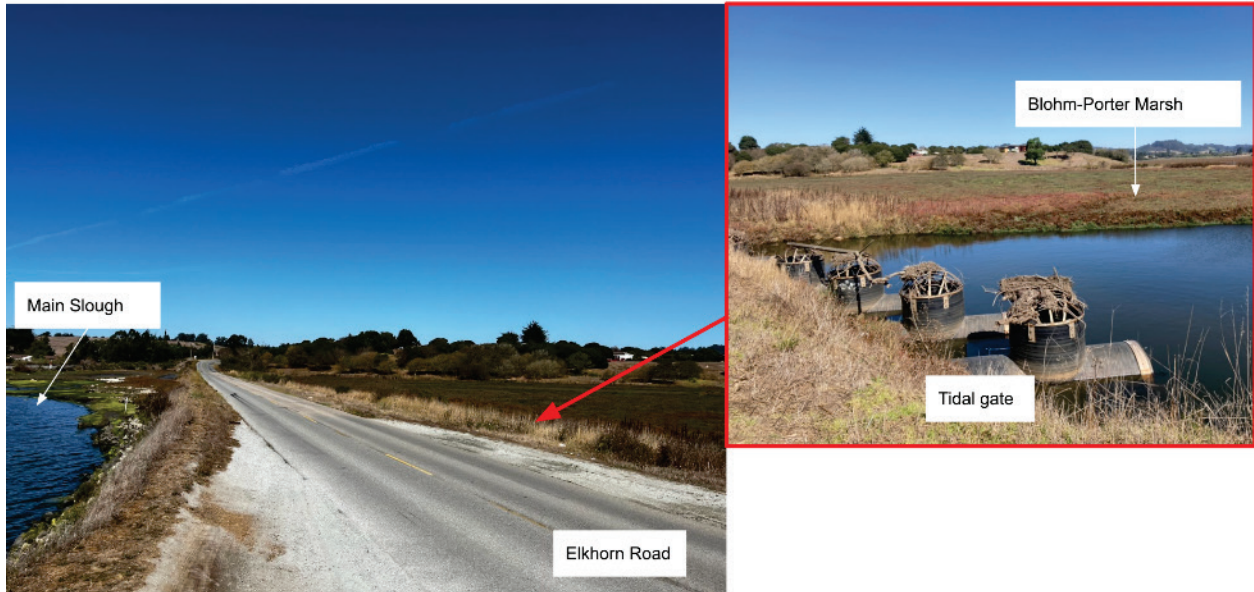
Figure 6. Tidal gate at Elkhorn Road separating the Blohm-Porter Marsh Complex from the main Elkhorn Slough channel. The Blohm-Porter Marsh Complex is at a noticeably lower elevation than the land on the other side of the road by the slough channel.

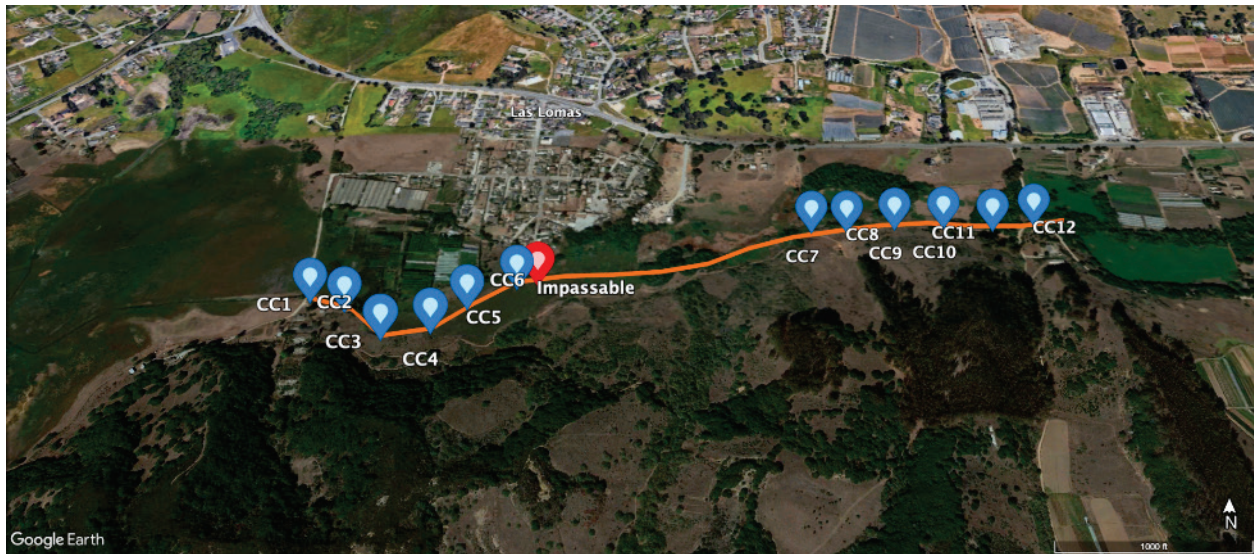
Figure 8. Sampling locations along Lower Carneros Creek. There were 12 sampling sites in total and are marked as “CCX” with “CC” signifying Carneros Creek and “X” signifying the sampling number and these sites are marked in blue. The red mark indicates the beginning of the impassable stretch of the creek; this continued until CC7.

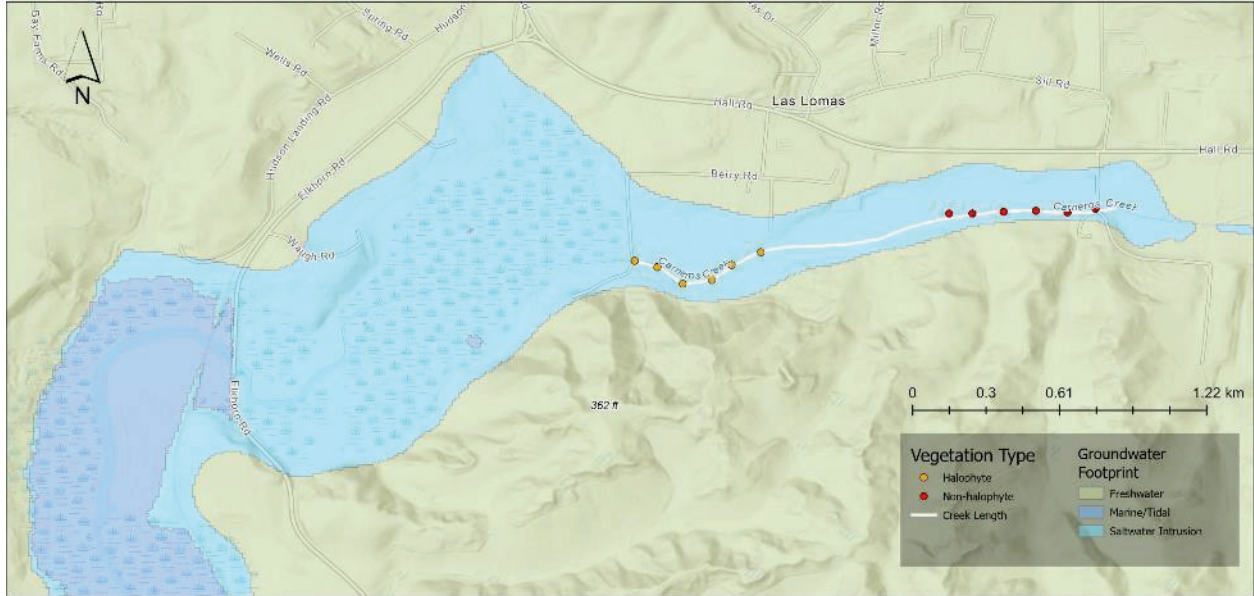
Figure 10. Points of survey sites along Carneros Creek from Blohm Road to the Eastern ranch road with or without halophytic species overlaid onto the groundwater footprint during a .25m sea-level rise scenario with a Kh of 0.1.

Our results show that sea-level rise induced groundwater rise and saltwater intrusion will impact the LCC and the Blohm-Porter Marsh Complex. The system is currently managed as freshwater-brackish through the use of tidal gates, but historical ecology and current vegetation compositions along LCC show that this system was historically tidally influenced and retains tidal wetland vegetation compositions (Figure 10; Table 1).

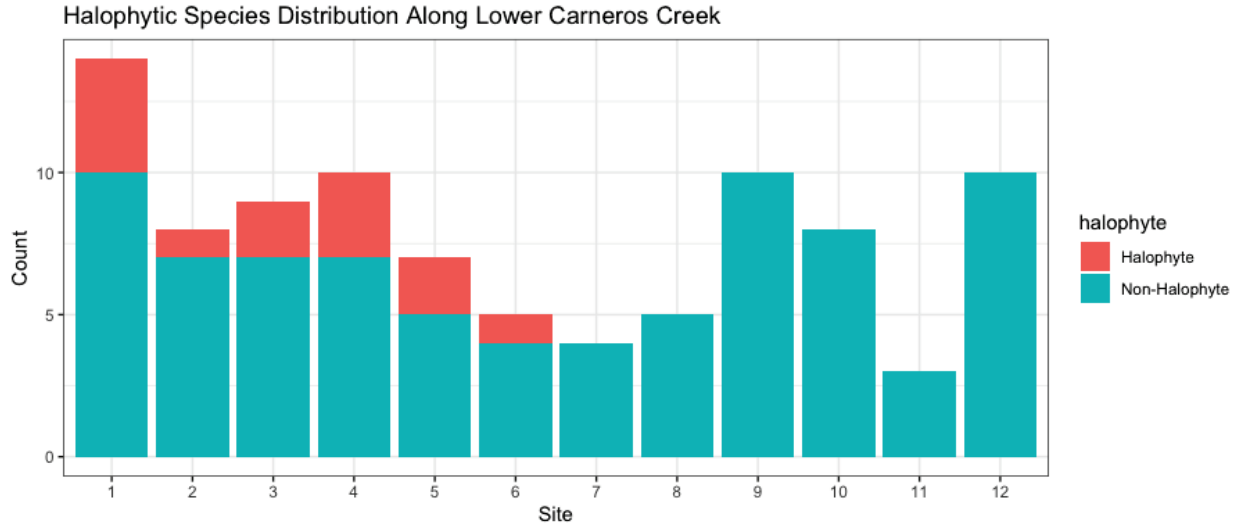
Figure 12. Halophytic Species vs Non-Halophytic Species across LCC sampling sites

These results demonstrate that, even with existing tidal controls, saltwater will intrude underground into the Blohm-Porter Marsh complex and Lower Carneros Creek (Figure 12). These hydrological changes will alter the vegetation composition in the riparian zone, including the extent of our sampling area. As our vegetation data demonstrates, halophytic species are already present in the riparian areas. We can infer that as groundwater rises, the middle and upper segments of Lower Carneros Creek will be inundated for longer portions of the year and potentially exposed to salinized groundwater. These implications may be less severe if groundwater overdraft occurs via pumping activities, however saltwater intrusion may occur more rapidly due to saltwater up-coning. These changing physical conditions will likely result in plant composition shifts. Freshwater riparian species like *Salix spp.* have low saltwater tolerances and will likely be imperiled as soil salinity increases. These conditions will support species that can withstand inundation for long periods of time as well as salinized soil conditions (RI Coastal Resources Management Council, 2007).

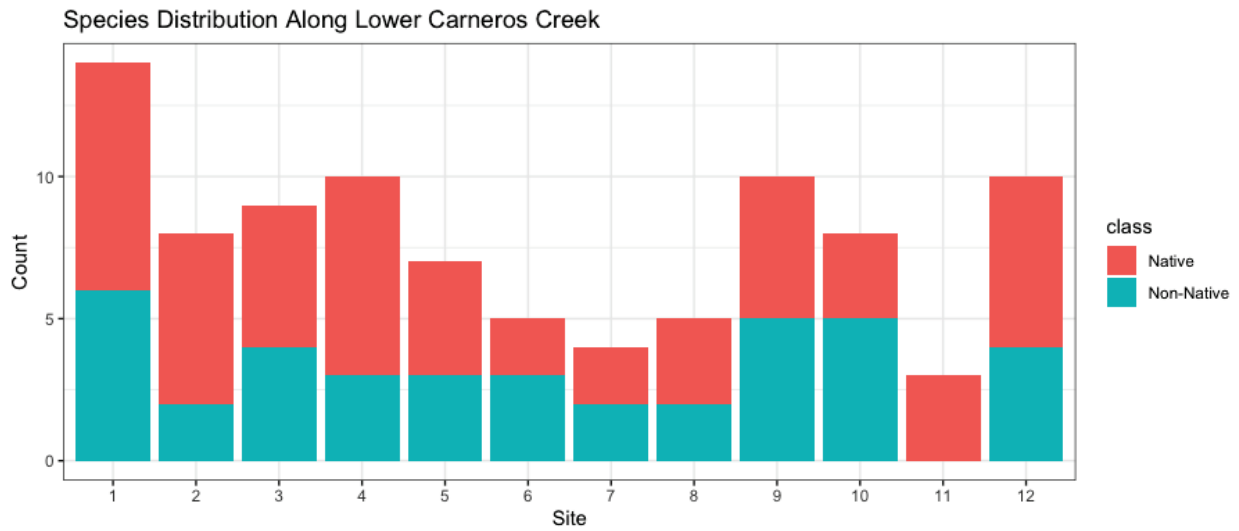
Figure 13. Native Species vs Non-Native Species across LCC sampling sites

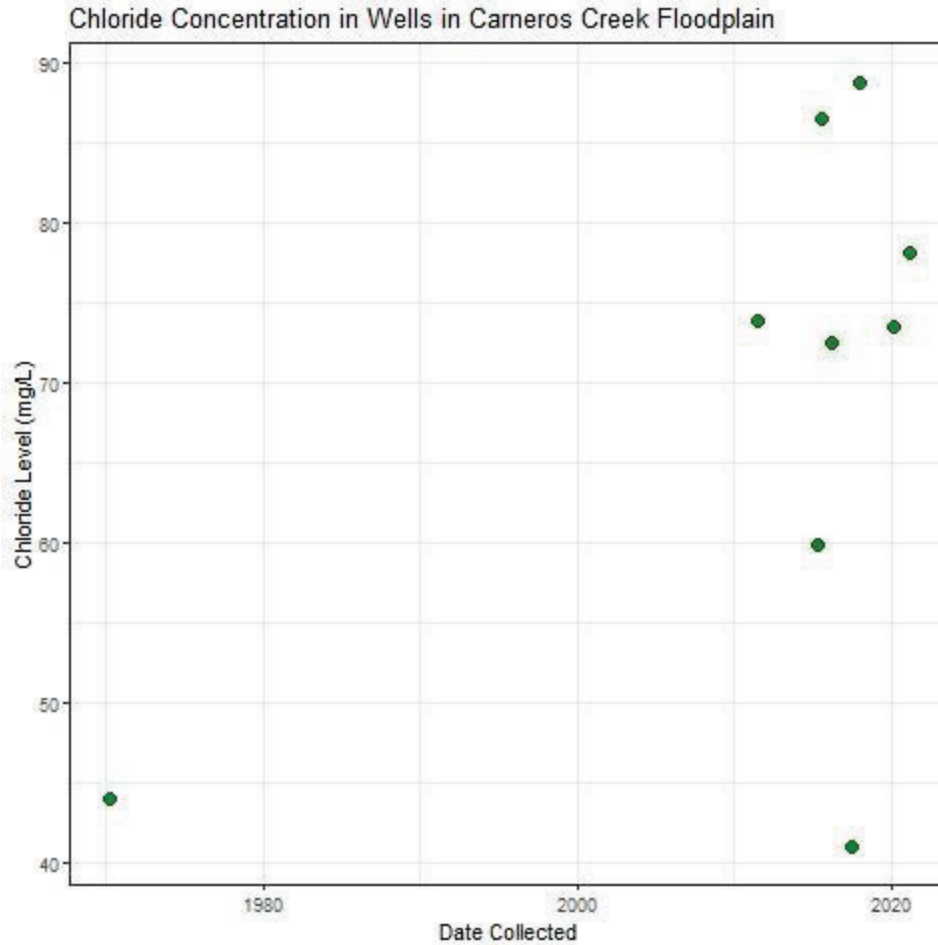
Supplemental Figure 1: Chloride levels for Carneros Creek based on the date they were collected.

Within the saltwater intrusion footprint (also referred to as the saltwater wedge), there are 207 observations for the wells in the GAMA dataset. Of those 207, seven observations were for chloride and those measurement dates range from 1970 to 2021. The range of chloride in these wells is 40.95mg/L-88.79mg/L (Supplemental Figure 1).
